# REFURBISHMENT PROJECTS

— THE JOURNAL OF REPAIR, REPLACEMENT AND MAINTENANCE —  
FEBRUARY 1994

# Scagliola restoration at the Athenaeum

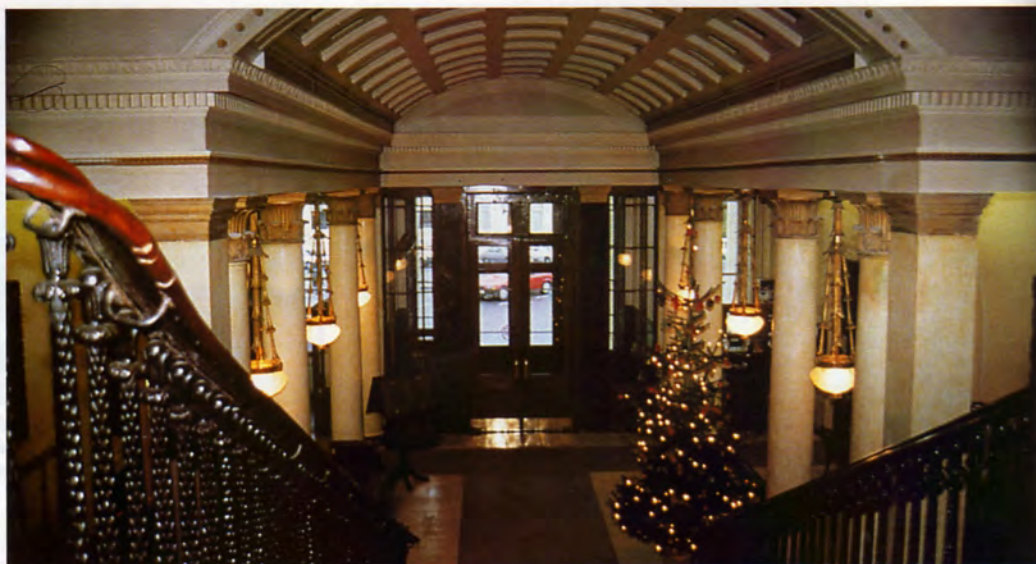
The restored round and square columns and pilasters in the entrance hall of the Athenaeum

In this latter club, The Athenaeum, The Scagliola Company was asked to carry out extensive restoration on some sixteen full size, round and square Scagliola columns and pilasters, situated in the entrance hall.

This Scagliola work although original, had been covered with numerous layers of oil-based paint, the last one being a gloomy dark green.

1. the stripping of the layers of paint, and
2. the bringing back of the original surface.

During this stage any trace chemicals (although neutralized) left from stage one, were washed and poulticed out of the surface of the Scagliola. Then the rough and uneven surface of the columns was eventually smoothed down by hand finished processes. During this stage, as various areas were getting smoother and visually clearer, various stains were beginning to emerge; these were tackled individually with poultices and other agents according to their severity. This erratic staining was due partly to external pollution factors, but mostly due to decades of smoking. This was more visually evident of course, as the columns were white!

gaps and tiny air-holes took place, with plaster slips of similar colour, followed by sanding of the surface with a suitable sandpaper and water. Eventually, we were able to obtain a smooth and hard surface, which was left to dry, ready for the polishing. This was done by rubbing on the surface consecutive layers of oil, specially

suitable for 'whitework', which is a slightly different oil used for the polishing of highly coloured Scagliola. The work was eventually buffed to a shine, revealing all the subtle veining, colours and pattern of the original work as the artisan would have constructed in his workshop many decades ago.

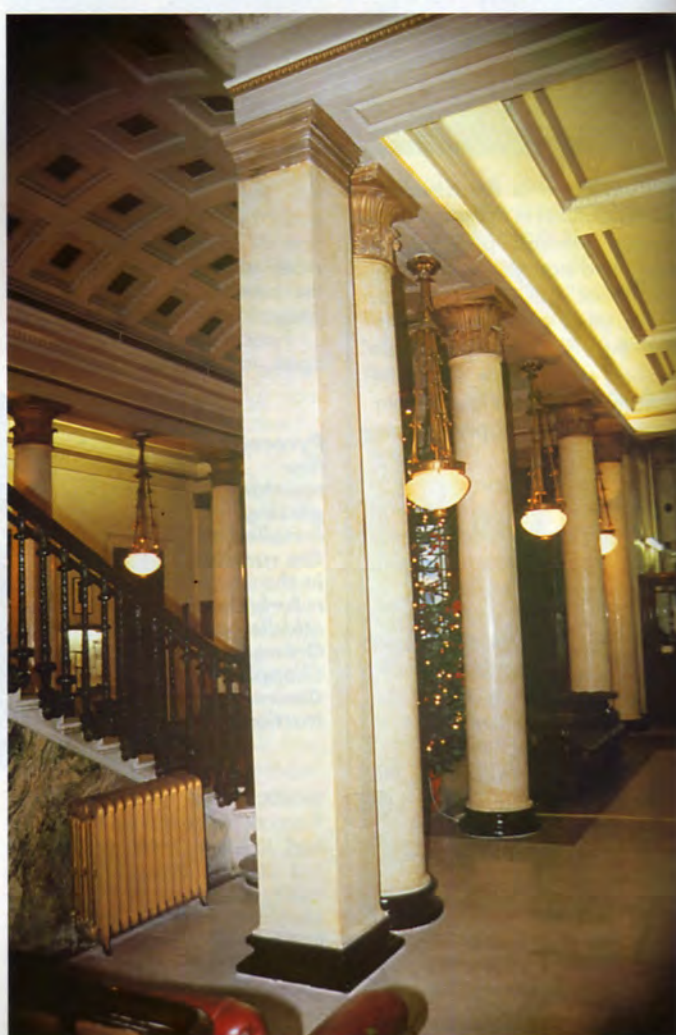
After easing most of the stains off, the usual fillings of
