REFURB
PROJECTS
JUNE 2006

HYLANDS HOUSE

by The Scagliola Company

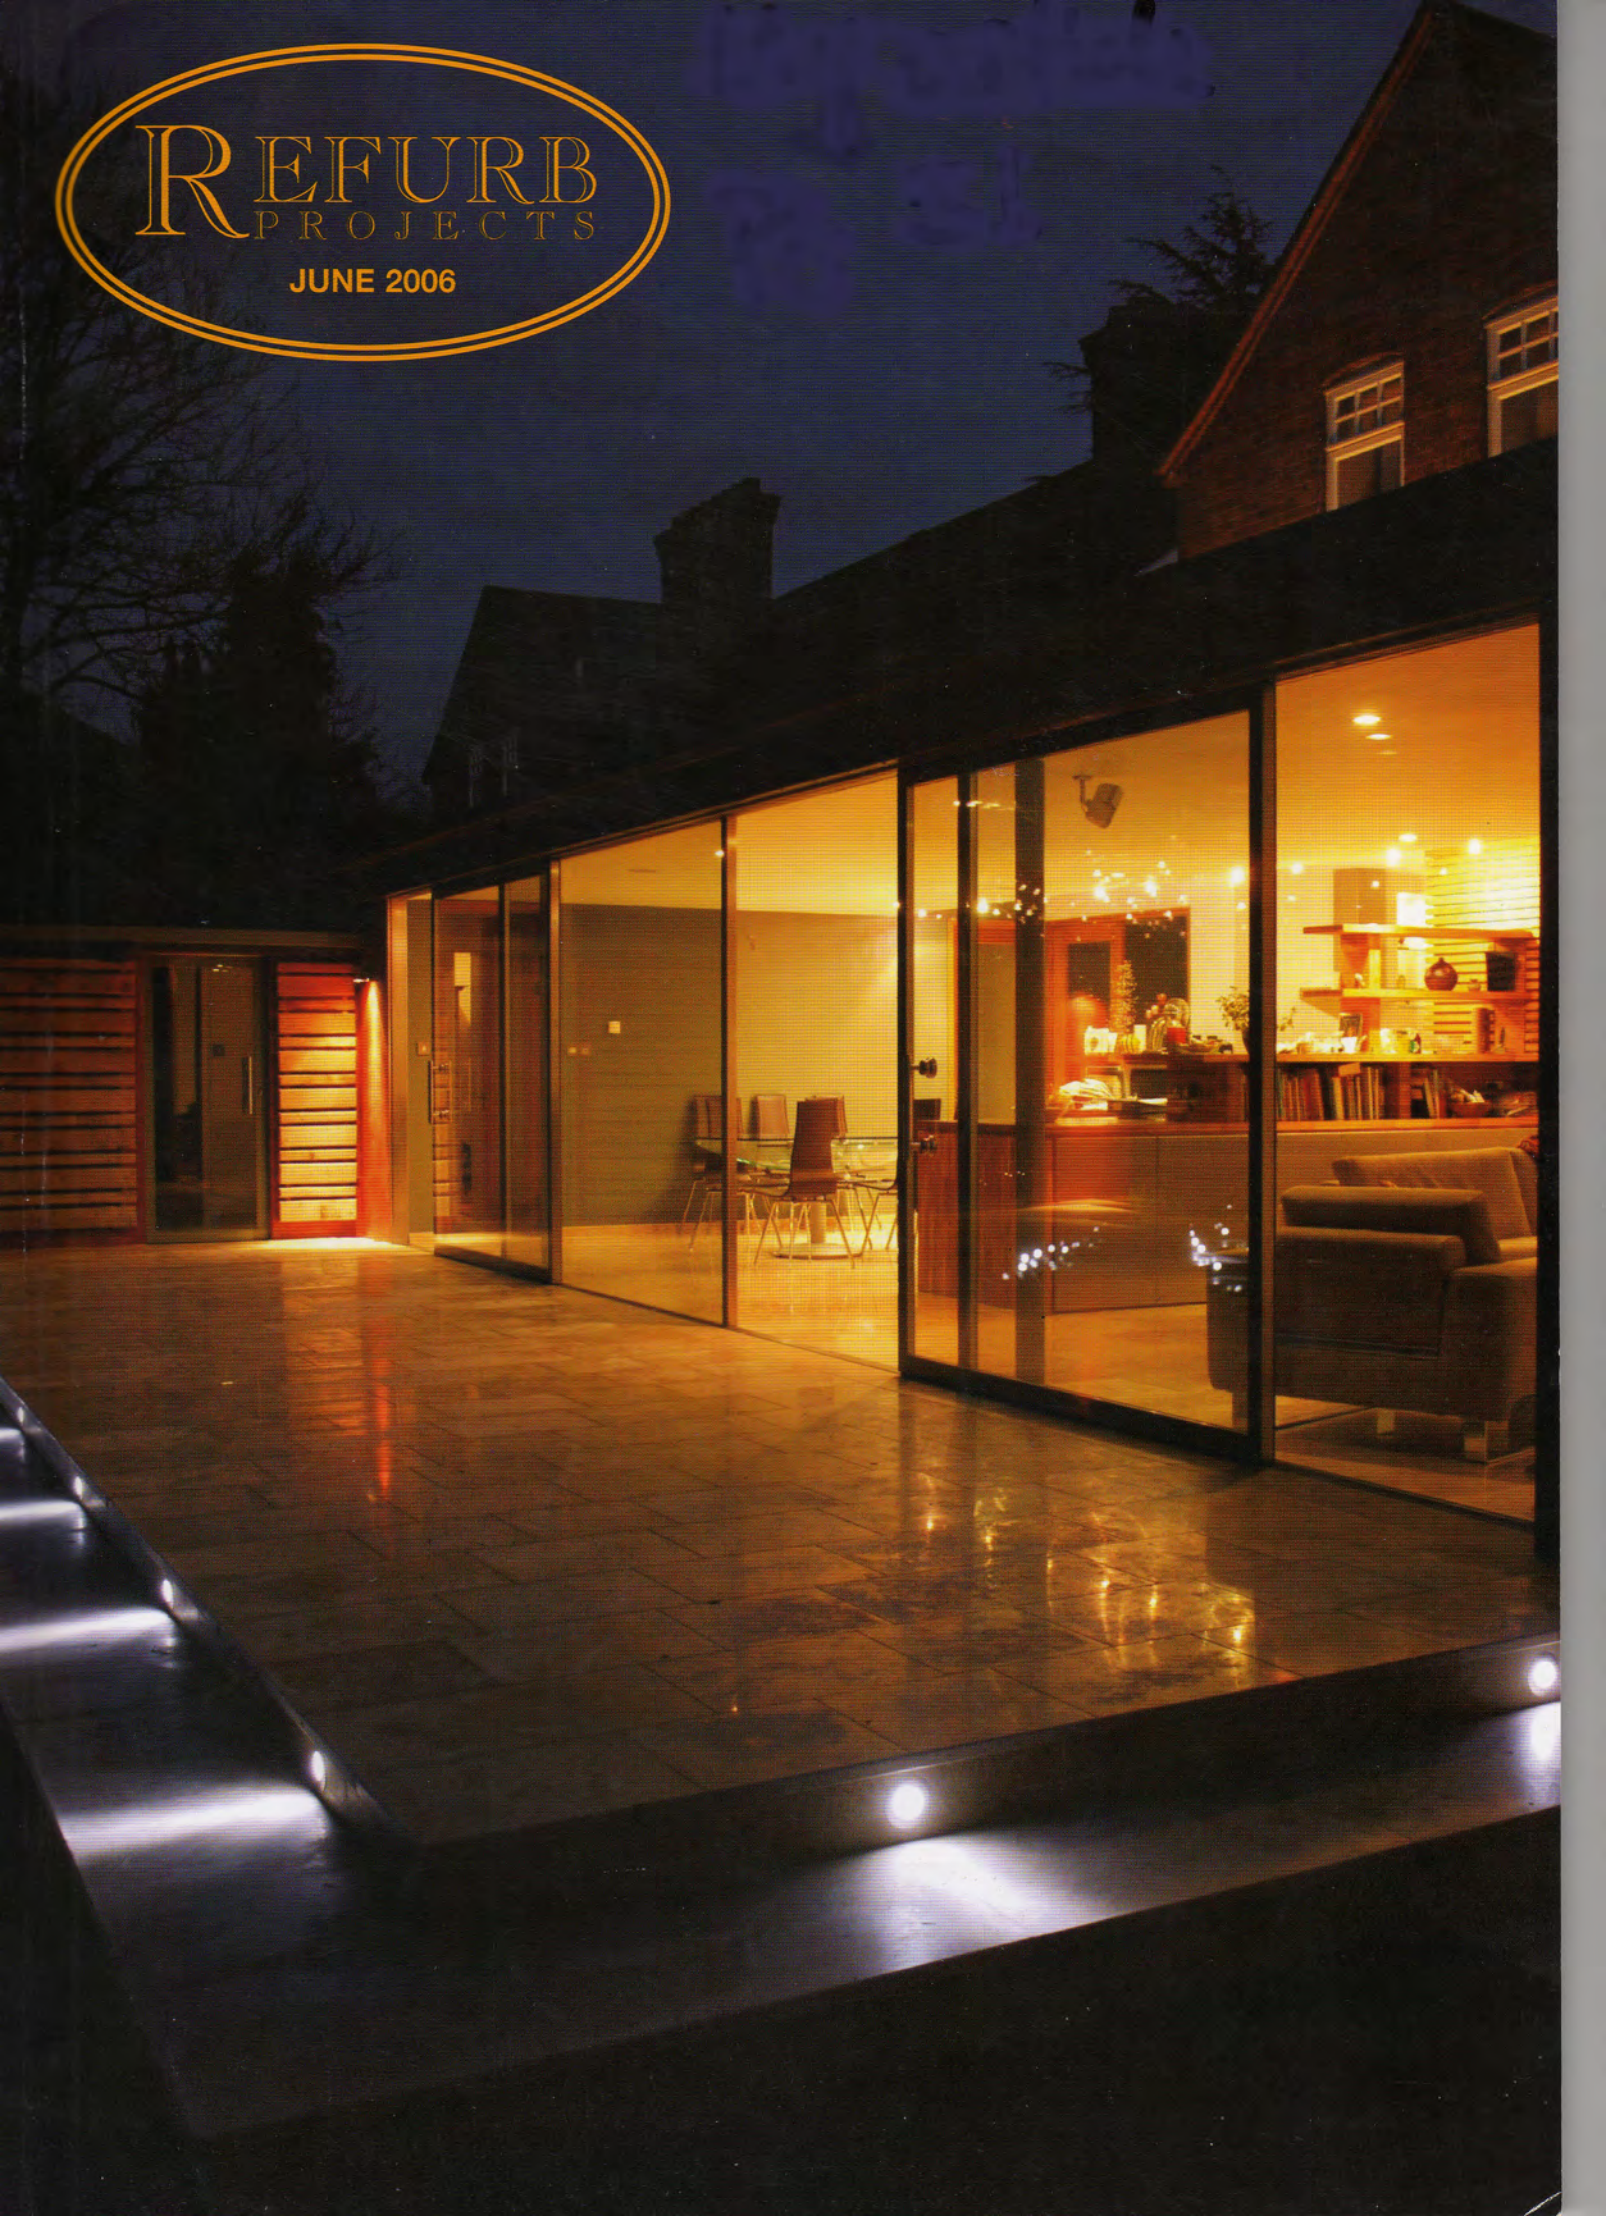
The work was covered with multiple layers of white paint which when partly stripped back revealed a pair of tall Jasper pilasters downstairs and a pair of Sienna pilasters upstairs. There were many losses that had to be meticulously re-instated. In particular a very 'difficult' section at the bottom of one of the Sienna pilasters as one of the photographs portrays which involved a certain amount of moulded elements.

The complete and careful stripping of all 4 pilasters exposed all the blemishes and areas of loss and revealed their sorrowful recent past before the restoration programme commenced.

At this stage different colour batches were constructed to duplicate the various colours ready for the most important phase of the work, the re-instating of all of the missing sections. The large missing base section drew upon the full knowledge, expertise of years of restoration of Michael Koumbouzis, who was undertaking the restoration with a small team. Firstly the background body of the work had to be built up as there were only wooden laths showing. This was done with a compatible plaster of Paris suitable for this type of background work. This was then keyed and left to set properly, ready for taking the Scagliola layer as a veneer.

Previous colour tests ensured a good colour and pattern compatibility for the Sienna work and the various Scagliola strips were applied onto the keyed plaster backing 4-5 mm thicker than the finished surface. When set, planning and subsequent numerous sanding and filling 'married' the new Scagliola with the original. When sufficiently dry the whole of the work was polished resulting in a very good match indistinguishable even to the most discerning eye.

Lastly we were asked to duplicate a Sienna pilaster to the exact colour, pattern and dimension to reflect the 'scheme' on the opposite side of the grand staircase. Having taken careful measurements, this work was constructed in the workshop and installed on site with pleasing results.
